LAKE PRIMROSE DAM

ST. FRANCOIS COUNTY, MISSOURI

MISSOURI INVENTORY NO. 30904

PHASE I INSPECTION REPORT
NATIONAL DAM SAFETY PROGRAM

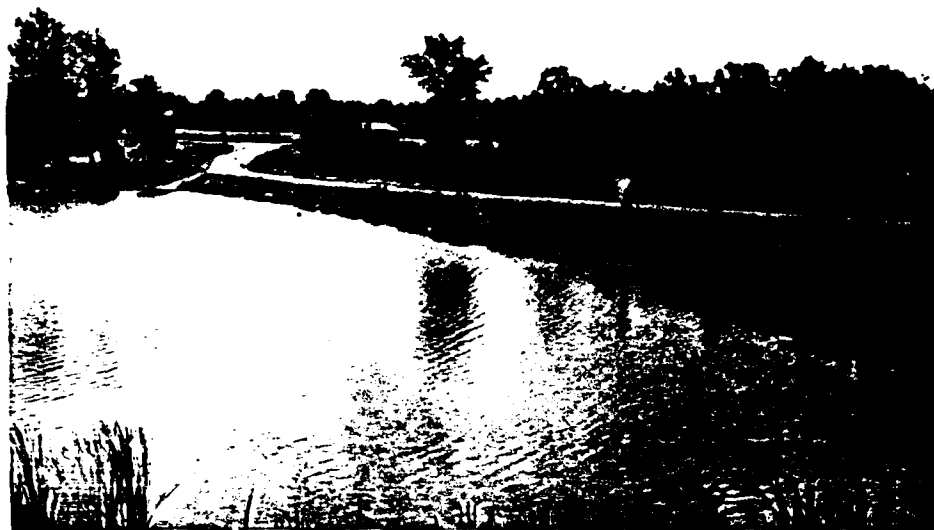
PHOTO 1: Overview of Lake and Dam.

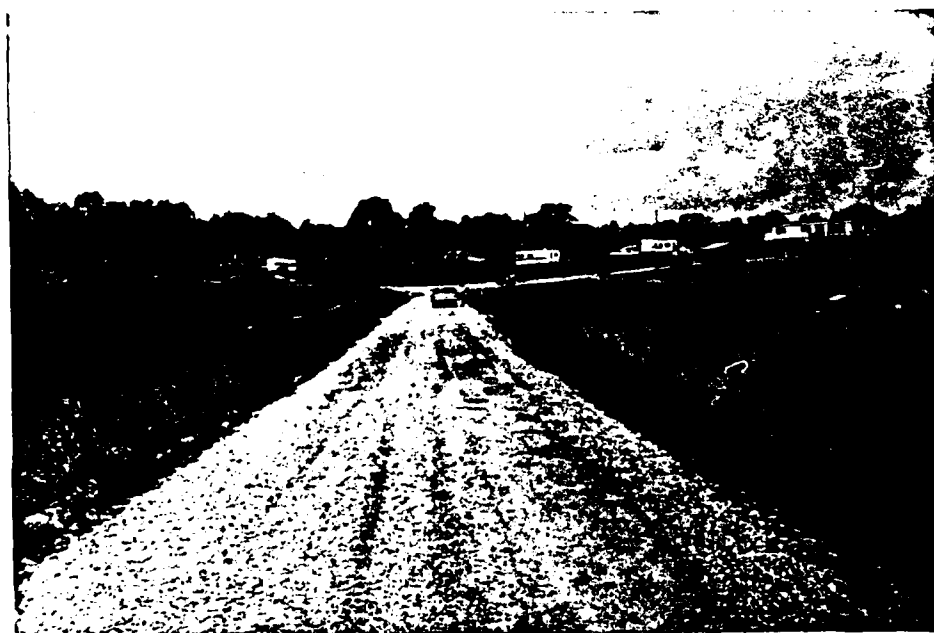
PHOTO 2: Crest of Dam.
